FIELD INSPECTION REPORT GREENS CREEK MINE

Inspection Date: October 11, 2007
Report Date: December 28, 2007
Weather: Cloudy. Temp 48°F., Wind 7mph with gusts to 21mph
Inspection Objectives: Routine inspection to follow up on informal site visits on May 30, 2007 and June 8, 2007
Operator Contact: Kerry Lear, Kennecott Greens Creek Mining Co. (KGCMC)
State Personnel: Ed Emswiler, ADEC Solid Waste Program
Kenwyn George, ADEC Wastewater Program
Other Personnel: Sarah Shoemaker, USDA Forest Service
Documentation: Photos were taken. Additional photos to those in this report are available from ADEC in Juneau

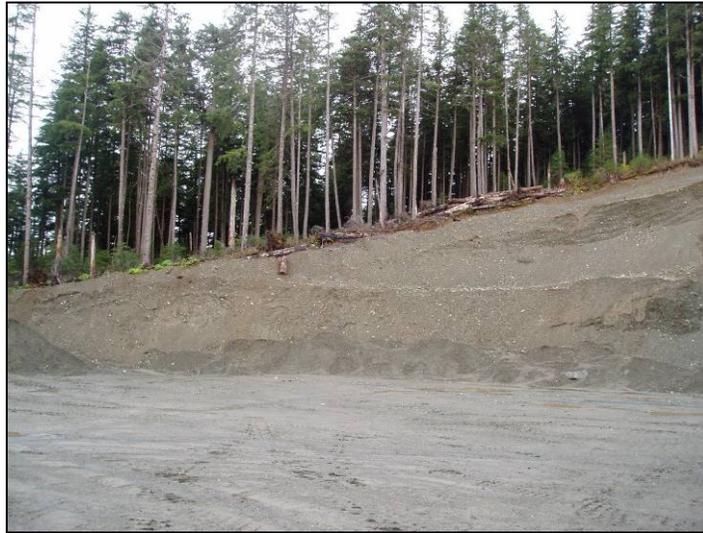
The site is located adjacent to the A-road (see Figure 1) between Hawk Inlet and Young Bay. Sandy material is screened for use as the bedding layer, granular interlayer, and service layer in the liner system at the northwest expansion area of the tailings facility as well as other uses around the KGCMC facilities. This pit is presently 5 acres but could be expanded to 10 acres in

Figure 1: 1.4 Mile “A” Road Sand Pit

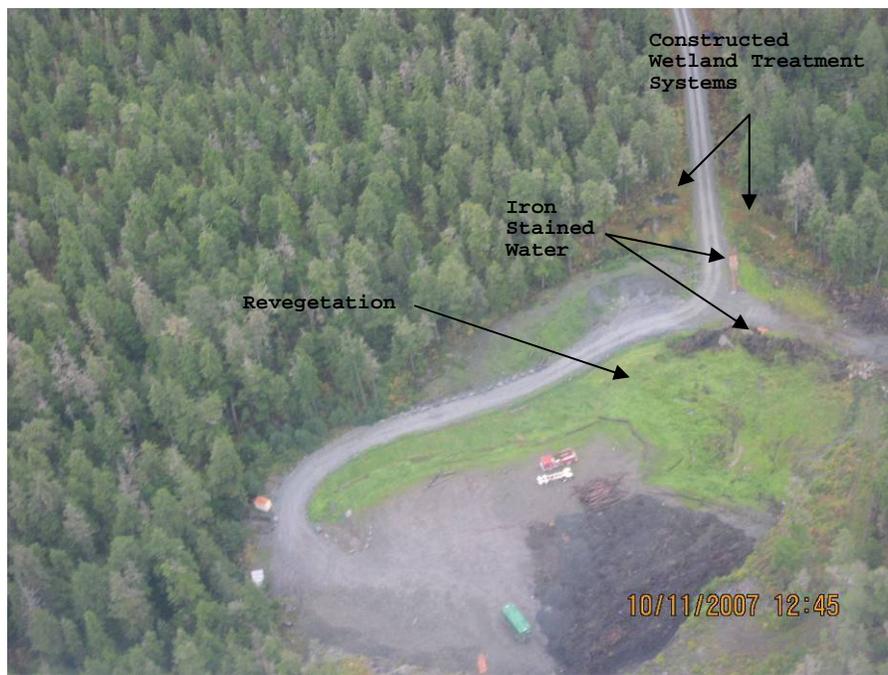
This pit is located approximately 200 yards off of the “A” road at mile 1.8 between Hawk Inlet and Young Bay (see Figure 2). The pit was initially developed in 1987 to support construction of the roads and other mine facilities. Pit 7 has been partially backfilled with tree stumps and reclamation materials derived during the expansion of the tailings pile and development of the sand pit at 1.4 mile on the “A” Road. KGCMC plans to recover this material for reclamation. Most of the surfaces and banks of placed materials had been given a heavy application of hydroseed and a dense blanket of grass was growing.

Figure 2: Pit 7: Note Hydroseed, Iron Stained Water and Constructed Wetland Treatment System

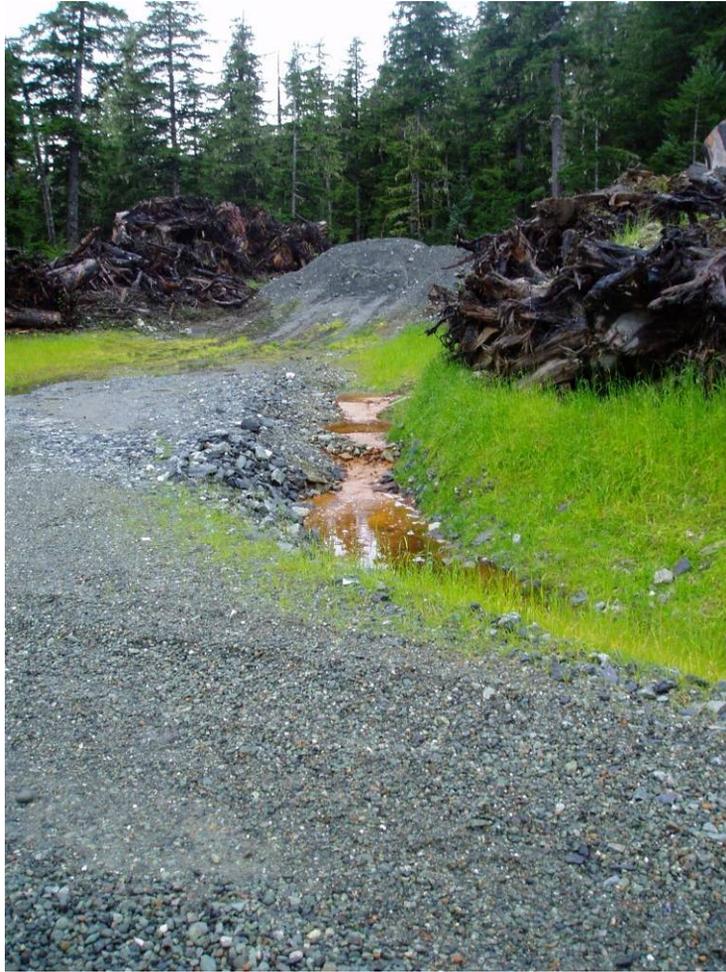
Iron staining was observed adjacent to road prisms and in water passing through stored overburden material (see Figure 3). The iron staining observed in the drainage from the pit is most likely due to dissolution of iron-rich oxide in the peat and gravel fill rather than from the pit walls (where iron staining has also been observed). Information from previous annual reports show relatively low sulfate concentrations and low metal values indicating limited sulfate oxidation.

Figure 3: Pit 7 Iron Stained Water Before Wetland Treatment System

Dissolution of iron and manganese oxides in the overburden stored in the pit has produced elevated concentrations of these metals and lead in the drainage.

1. Elevated lead concentration has been noted in drainages at Pit 7. Presently storm water is monitored within the constructed wetlands. EPA and Greens Creek are in the process of relocating the storm water compliance point to the outlet of the constructed wetland, just prior to the discharge entering the stream. Compliance with EPA stormwater benchmark values will be a point of interest in future evaluations.

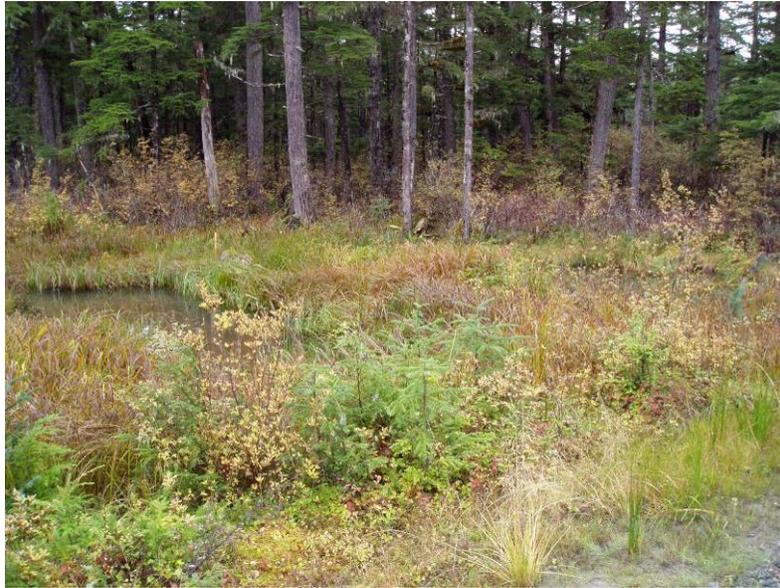
Two small wetlands constructed at opposite sides of the road to the entrance of the pit treat the water before it enters a water of the U.S. One constructed wetland has two ponds (see Figure 4). Oxidation of the drainage waters and precipitation of the metals is expected in the constructed wetlands. Presently storm water monitoring occurs at the outlet to the wetlands. However, the water then runs down grassy ditch extensions of the constructed wetland areas which provide additional treatment prior to entering a small stream considered to be “waters of the U.S.” by EPA. EPA and Greens Creek are in the process of relocating the storm water compliance point to the outlet of the constructed wetland just prior to the discharge entering the stream.

Figure 4: Constructed Wetland Treatment Systems at Pit 7

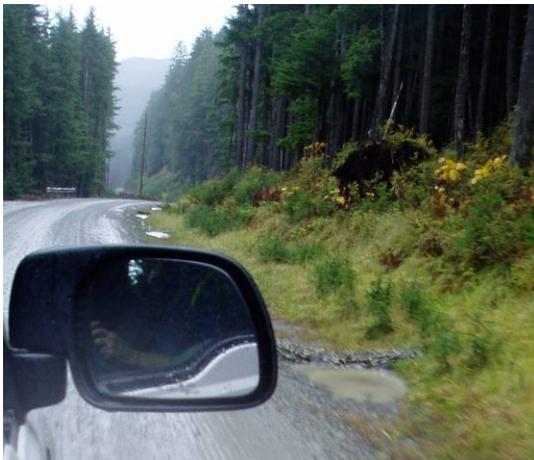
As per recommendation from Dr. Richard Warner (June 14, 2007 site visit) KGCMC has begun to experiment with rock check dams and “burrito wraps” as a means of further reducing sediment from roads. Burrito wraps are rock check dams wrapped in filter fabric to reduce the passage of sediment through the dam. Effective use of the dams allows sediment to precipitate by gravity before the water passes over and through the dams. Historically, straw bales were used. However, straw bales were not considered as effective as the rock dams as they degrade quickly and are less permanent. The check dams and “burrito wraps” have generally been given a favorable report thus far; however the burrito wraps tend to clog with sediment rather rapidly and so do not work quite as originally intended. The rock dams without fabric are also becoming filled with sediment, so it is early to tell how effective these are in the long term, and what maintenance will be required. Both check dam configurations were noted to have produced sediment capture in their up-stream pools (see Figures 5, 6, & 8).

Figure 5: Rock check dams on "B" Road

Proper placement, construction and maintenance of the check dams were reported as critical to the success of the dams. The dams becoming sealed with sediment is an on-going maintenance issue. During low flow situations, sediment drops out in the ponds behind the dams. However, sediment-laden waters may flow over the dams at times of high flows especially when they are not maintained or are not constructed adequately. Some ponds were observed to be full of sediment. Internal KGCMC monitoring has shown that greater attention to cleaning ponds and maintaining dams will be necessary and KGCMC staff has been alerted to this. KGCMC has purchased a suction truck to help with ditch maintenance as well as other sediment clean-up around the site. According to Kerry Lear, the rock dams will need to be replaced routinely (approximately every 3 years).

2. ADEC will continue to track the effectiveness of the following in reducing sediment from roads:
 - a. rock check dams;
 - b. burrito wrap check dams;
 - c. installation of more culverts;

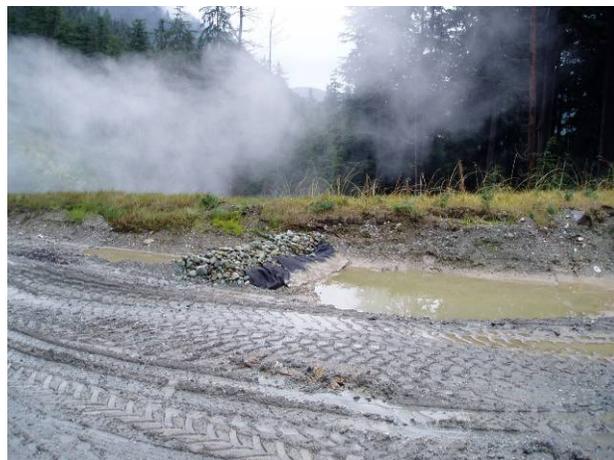
Figure 6: “Burrito Wrap” check dam at Site 1350

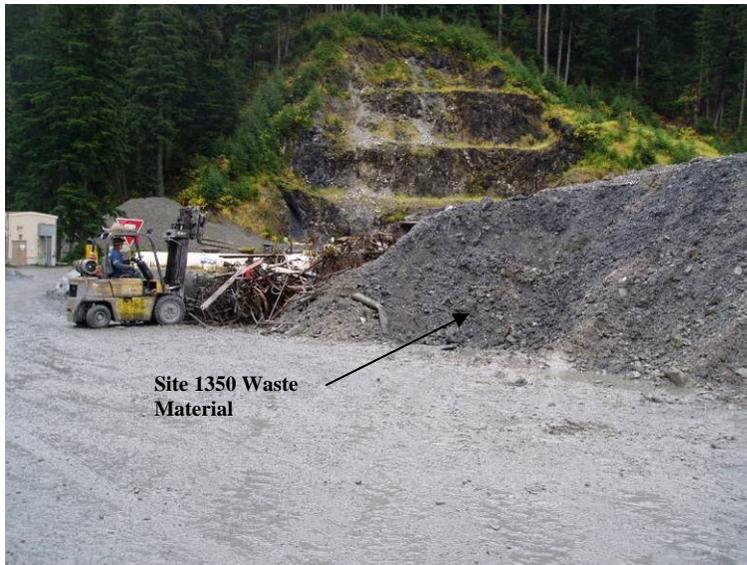
Figure 7: 920 remuck pad with site 1350 waste and inert construction wastes for placement underground

Approximately 2,500 tons of this waste was stored at the 920 remuck pad awaiting placement underground (see Figure 7). Approximately 10% of the waste at this site has been removed thus far and approximately 60,000 tons have yet to be removed. The class 2 material from the site will be disposed at Site 23. The area will be cleaned up and excavation will stop this year due to winter conditions. Removal of the waste will resume in the spring when conditions are favorable.

4. ADEC will continue to track the removal of approximately 60,000 tons of production rock at Site 1350.
5. ADEC will continue to track the effectiveness of the pumpback system, use of glacial till material in the downstream face at Site C pond, and improvements to the stormwater ditch that sheds water from the B-road between the 920 and Site C in reducing sporadic fluctuations in lead concentrations in Greens Creek below Site C.

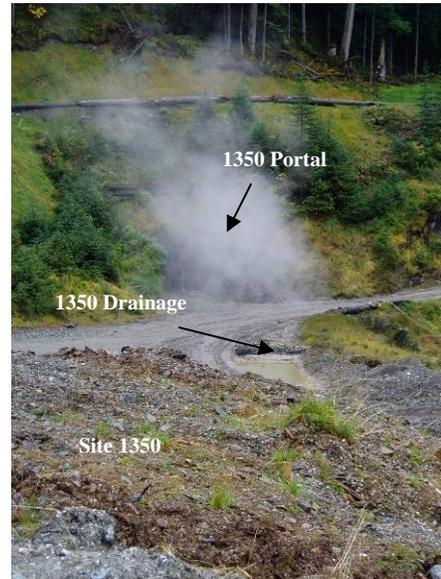
Figure 8: Contained stormwater from site 1350 and 1350 portal

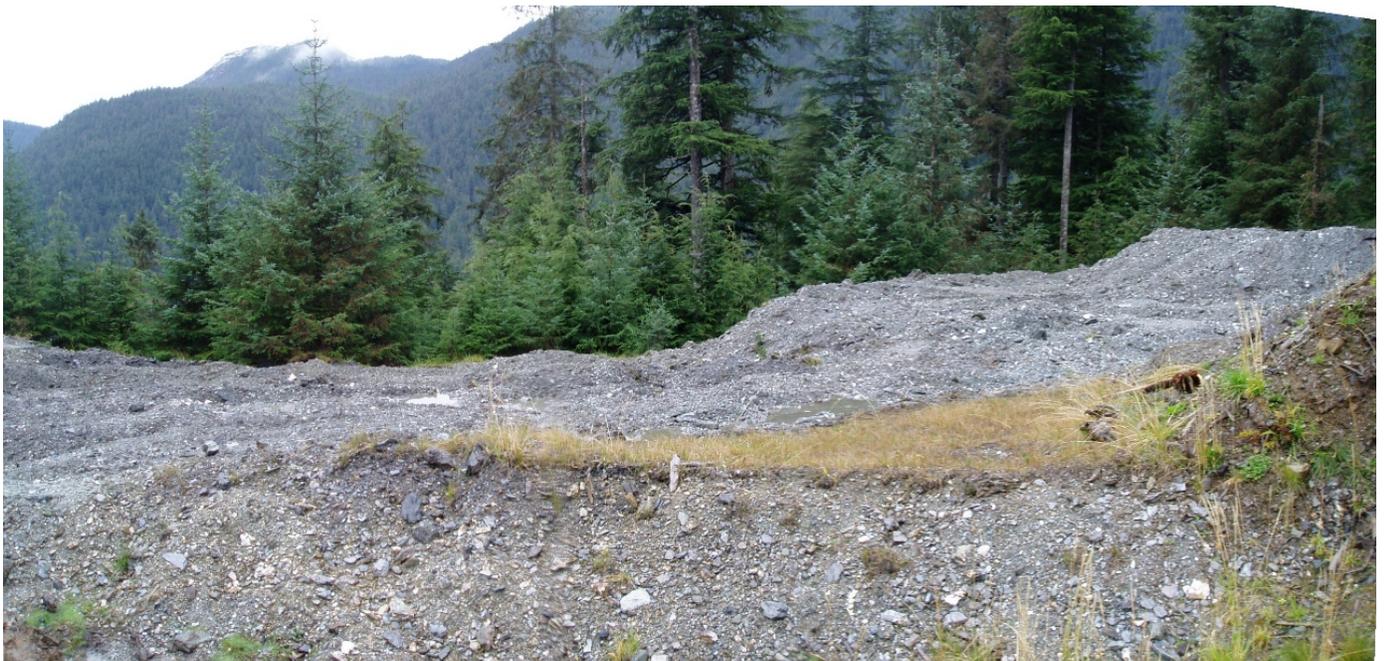
Figure 9: Area of Site 1350 excavation

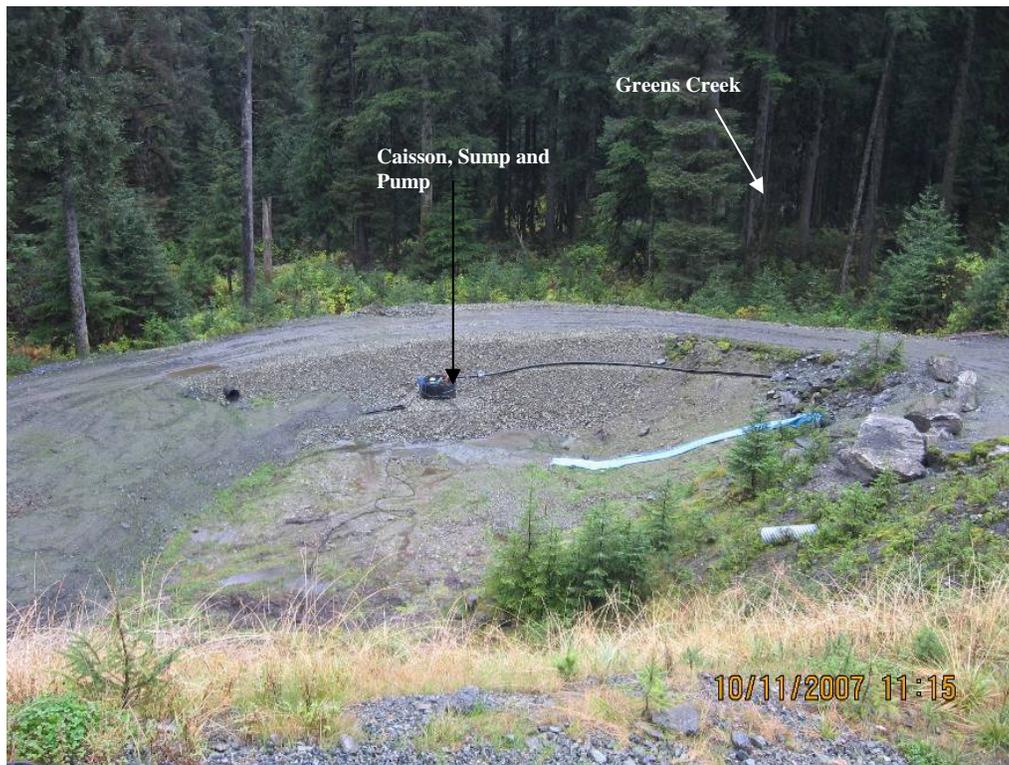
KGCMC completed installation of a pumpback system in 2007 to facilitate the recovery of collected stormwater to the pond. The recently installed sump facilitates return of these pond waters to the mine water collection and treatment system. However, during high flows, some seepage occurs on the downstream face of the pond and flows to Greens Creek. KGCMC proposes to place low hydraulic conductivity glacial till material on the downstream face to prevent this seepage.

Figure 10: Pond "C", Note: sump which pumps water to containment

Final reclamation bonding for Site C includes the use of an engineered cover system leaving the disposed material in place. Because of the close proximity of the site to Greens Creek, disposal underground with less hazardous portions disposed at Site 23 should be considered.

6. Because of the close proximity to Greens Creek, underground disposal of the more hazardous portions of production rock with disposal of less hazardous portions at Site 23 in the final reclamation of Site C should be considered. Currently, the plan and bond includes placement of an engineered cover over this site.

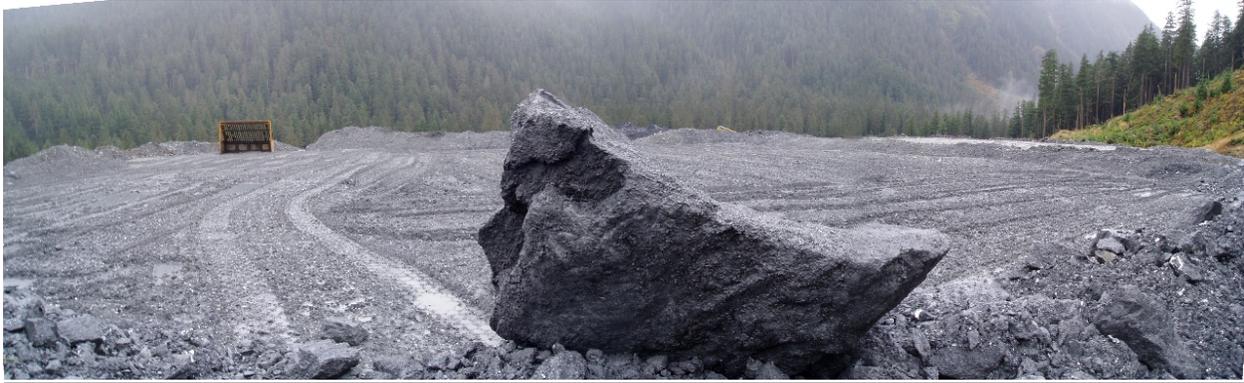
General site management at Site 23 focuses on efforts to place and compact waste, control infiltration, drainage, run-on and run-off. Infiltration is addressed by the use of a grading plan that must be flexible in order to account for seasonal conditions and the ever-changing pile top surface. Waste is typically placed with dozers in 2-foot lifts and then compacted with 3 passes of a vibratory compactor (see Figures 11 & 12). This is done in a way to minimize the formation of permeable areas and to allow water to drain off of the surface to the mine water collection and treatment system at Pond 23. At this inspection wet conditions presented drainage and accessibility issues. During wet weather rock rapidly breaks down into “soupy slurry” on the access road and other areas receiving heavy traffic (see Figure 13). This was difficult to manage, resulting in high sediment loads in surface runoff to the lined ditch and pond containment. It

was reported the slurry was scooped up and mixed with new rock, then spread out on the pile where the excess water was able to slowly percolate down through the pile. KGCMC is clearly aware of this problem and has experimented with a ridge and swale pattern that appeared to improve drainage during the rainy season. Fine tuning of methods to improve drainage and accessibility continues.

Figure 11: Site 23 southwest downslope. Note: drainage features

7. ADEC will continue to monitor the surface drainage improvements at Site 23 as fine tuning of methods to improve drainage and accessibility continues. KGCMC should focus efforts on how to control high sediment loads in surface runoff especially in wet conditions in areas of heavy traffic where drainage and accessibility present the greatest challenges.

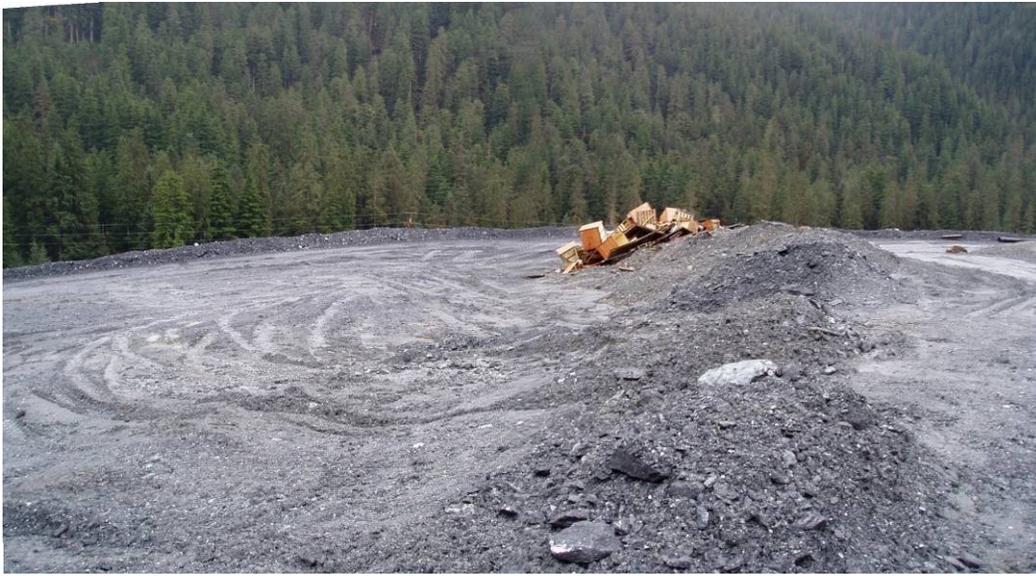
Figure 12: Site 23 south downslope drainage

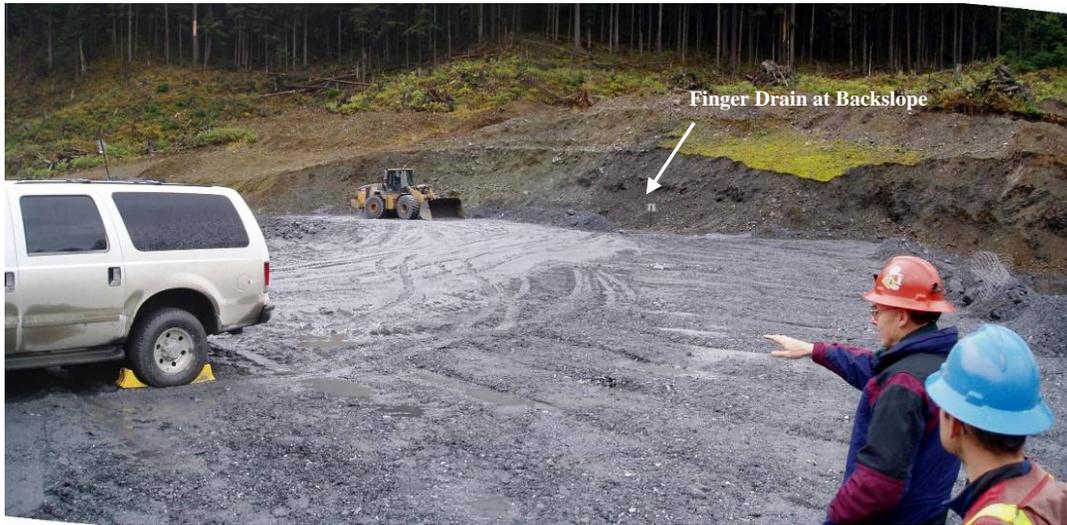
Figure 13: Site 23 north upslope footprint and “soupy slurry” on access road.

Drainage of water that percolates down through the pile is facilitated through a system of 8 underlying finger drains and a curtain drain system. Following back-slope excavation and prior to production rock placement, finger drains are extended to intercept water at the base of the waste rock (see Figure 13). The finger drains are constructed concurrently with backslope excavation using 6” slotted HDPE pipe bedded in gravel/rock and added in sections progressively upslope from the active placement area. The finger and curtain drain system is designed to prevent water accumulation in the production rock pile and to intercept groundwater flow into the overlying rock material at the contact of the production rock and apparently somewhat less permeable colluvium. This also acts to produce a free-draining pile which will enhance geotechnical stability. The finger drains discharge to the lined ditch paralleling the “B”

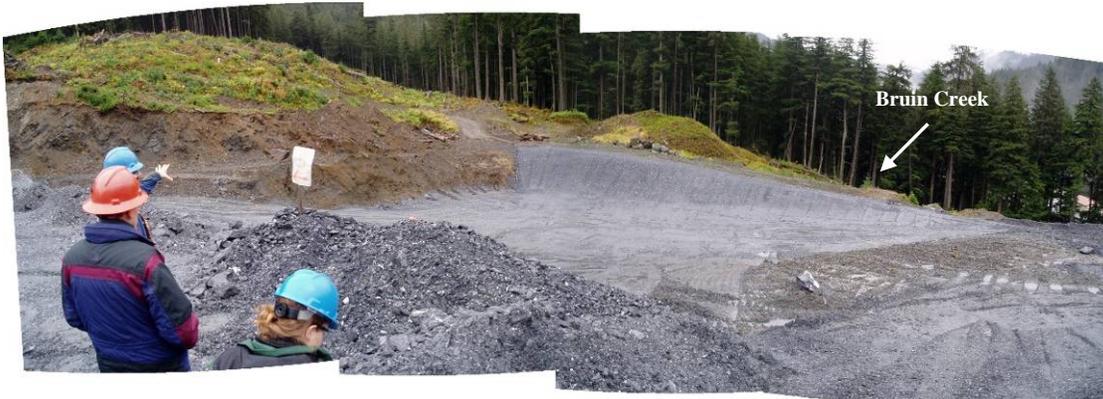
The northeast aspect of the site was being prepared to receive waste rock (see Figure 14). This was done by developing a berm of argillaceous rock with drains that are oriented to keep landfill associated water within the containment system. By keeping the boundary of the pile at this location, no water from the waste rock should run into Bruin Creek which runs adjacent to the site.

Figure 14: Site 23 northeast footprint. Note: Prepared foundation and berm to receive waste

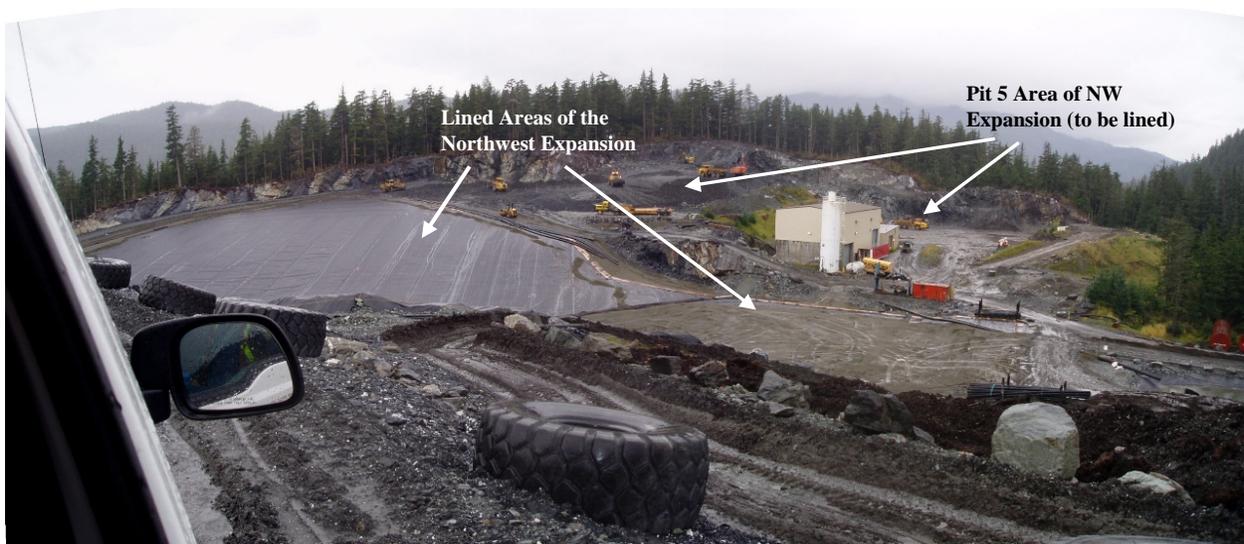
As noted above, the tailings material from the existing tailings pile, in the southwestern aspect of the NW expansion, were excavated to allow the liner to cover the full extent of the bedrock in this area, and tie into the natural till layer that acts as an aquatard below the site (see Figures 15, 16, and 17). A plastic tarp was placed over the open tailings face in order to minimize the phreatic water surface level in this area. According to KGCMC the phreatic water surface level was lower than expected as noted after excavation in this area of tailings. This may be cause for recalculating stability figures and the factor of safety for the tailings both of which will be enhanced with the confirmed lower saturation level in the pile.

Figure 15: Tailings NW Expansion Area: Note area to the left that ties in to the natural till layer (aquatard)

14. The results of a Construction Quality Assurance (CQA) plan conducted for the Northwest Corner Expansion area of the tailings disposal facility is needed. A similar CQA program should also be conducted when the geosynthetic liner is placed in the Pit 5 area of the Northwest expansion area. Results should be submitted prior to tailings placement.

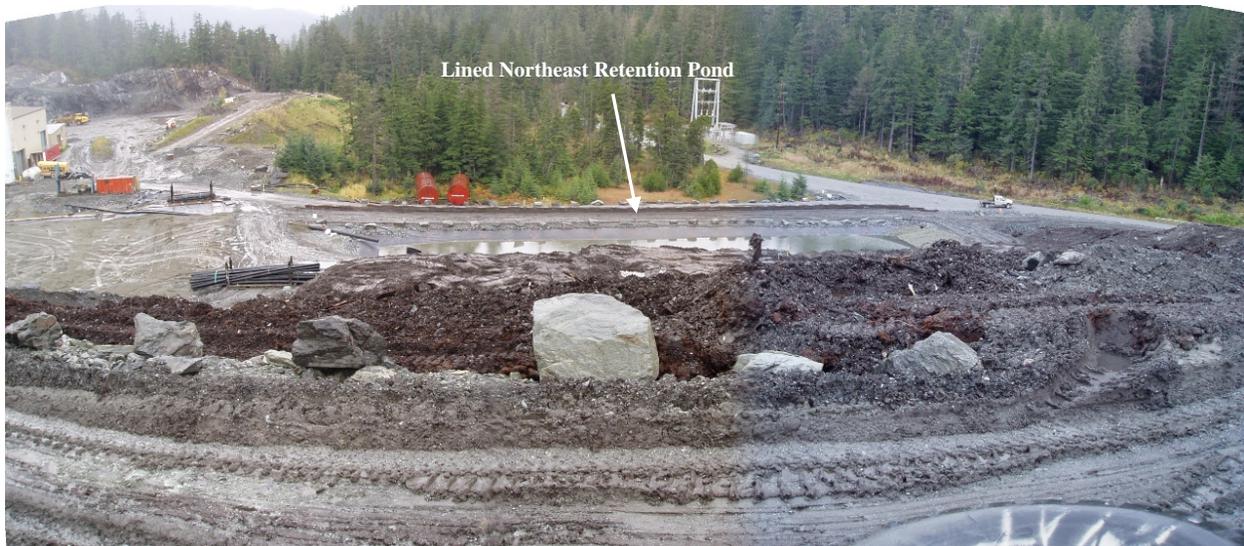
Figure 16: Northeast Retention Pond

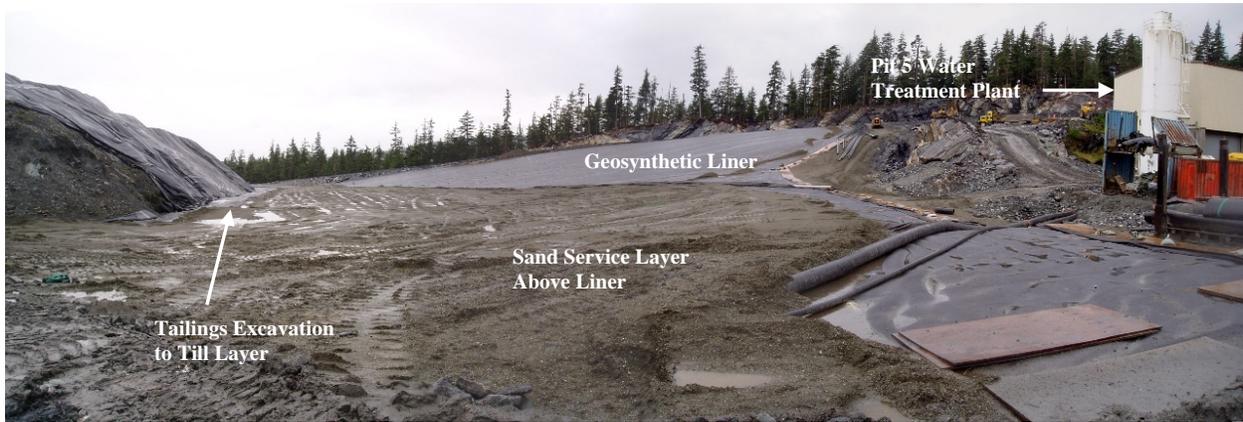
Figure 17: Southern aspect of the NW Expansion. Note tailings excavated to natural till layer to allow the liner to tie in to the natural till layer
